# **Pentium<sup>®</sup> III Xeon<sup>™</sup> Processor Specification Update**

Release Date: October 1999

Order Number: 244460-007

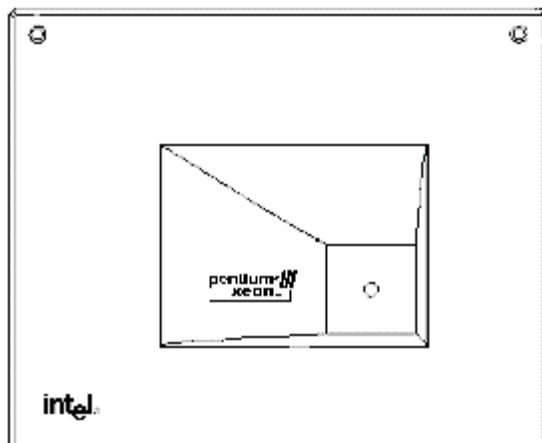
### *Pentium® III Xeon™ and Boxed Pentium® III Xeon™ Processor Markings*

#### *Production Dynamic Mark Example:*

500/512/100/2.0V S1  
 FFFFFFFF-NNNN {country}  
 i®'98 SSSS
